## 5.G RIO DE LAS VACAS

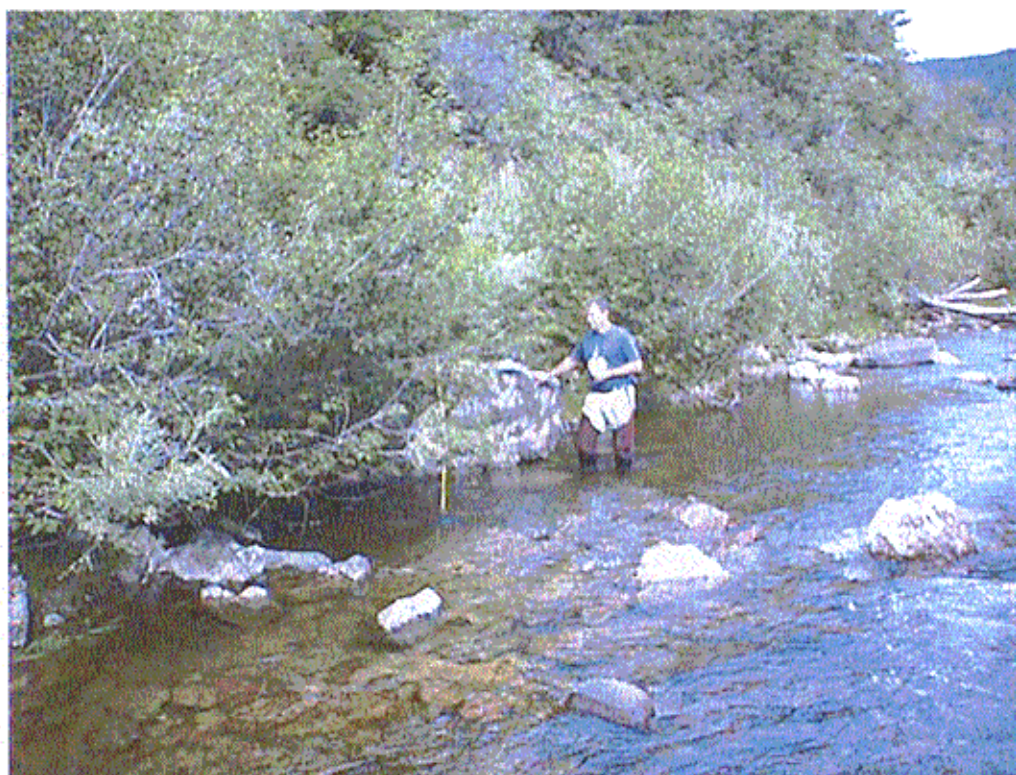
Photo 10. Rio de las Vacas (NMED Lower Sampling Station 18 – Thermograph T6)

The Rio de las Vacas above the Rio Cebolla (Station 18) showed exceedances of the TOC criterion on each of the three days of the Fall sampling effort, most likely due to decomposing deciduous vegetation. The water at this station was cold to moderately warm, well oxygenated and had low to moderate levels of dissolved constituents. This location is rather broad and shallow with little canopy cover, despite a healthy riparian area.

Consequently, there were exceedances of the temperature criterion at this station as well. A thermograph was deployed at Station 18 on July 16 and retrieved September 29, 1998. A total of 1,795 temperature readings were made during this period and the thermograph location is shown in the photograph on the preceding page. The readings varied from 6.0 to 24.5°C. The average of all temperatures was 15.5°C and 218 measurements exceeded the numeric standard of 20°C.

At Station 18, the average TOC concentration for the three days during the Fall was 7.4 mg/L, which is an exceedance of the chronic criterion of 7 mg/L.

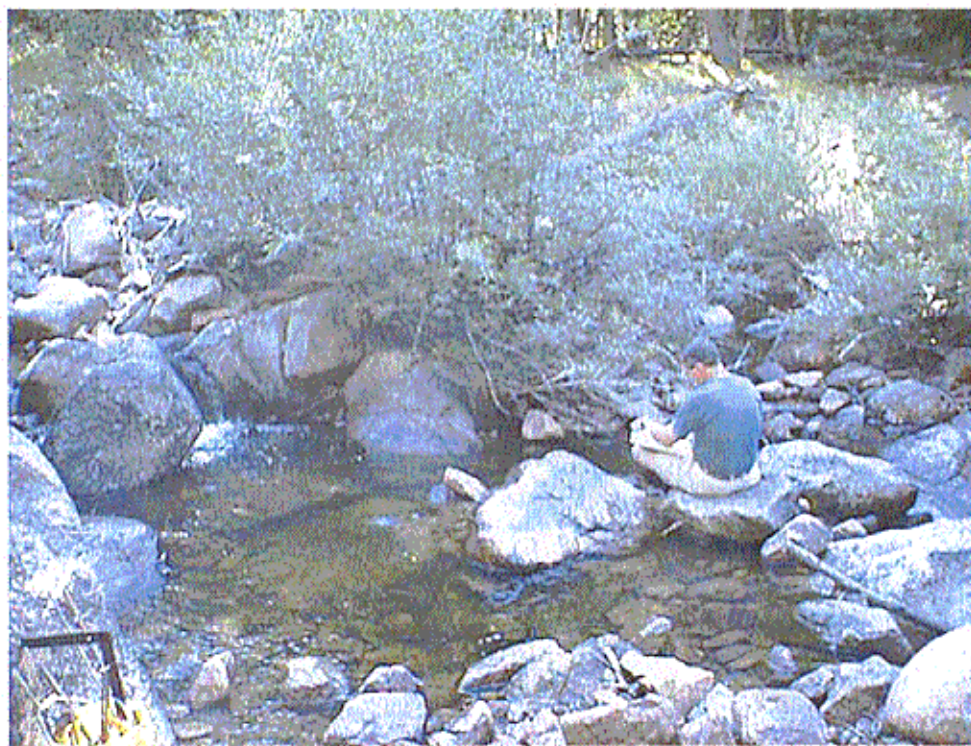
**Photo 11. Rio de las Vacas (NMED Upper Sampling Station 19 - Thermograph T5)**

The Rio de las Vacas upstream from Rancho de Chaparral Girl Scout Camp (Station 19), shown above, was also sampled and results were similar to Station 18. There were single exceedances of temperature and TOC during the Summer run, and three exceedances of the TOC criterion in the Fall. The water varied from cold to moderately warm and was described as well-oxygenated and had low to moderate levels of dissolved constituents. A thermograph was deployed at this station as well and a total of 1,793 temperature readings were recorded. The average of all temperatures was 17.0°C, temperatures varied from 7.0 to 27.0°C, and 375 measurements exceeded the numeric temperature criterion of 20°C.

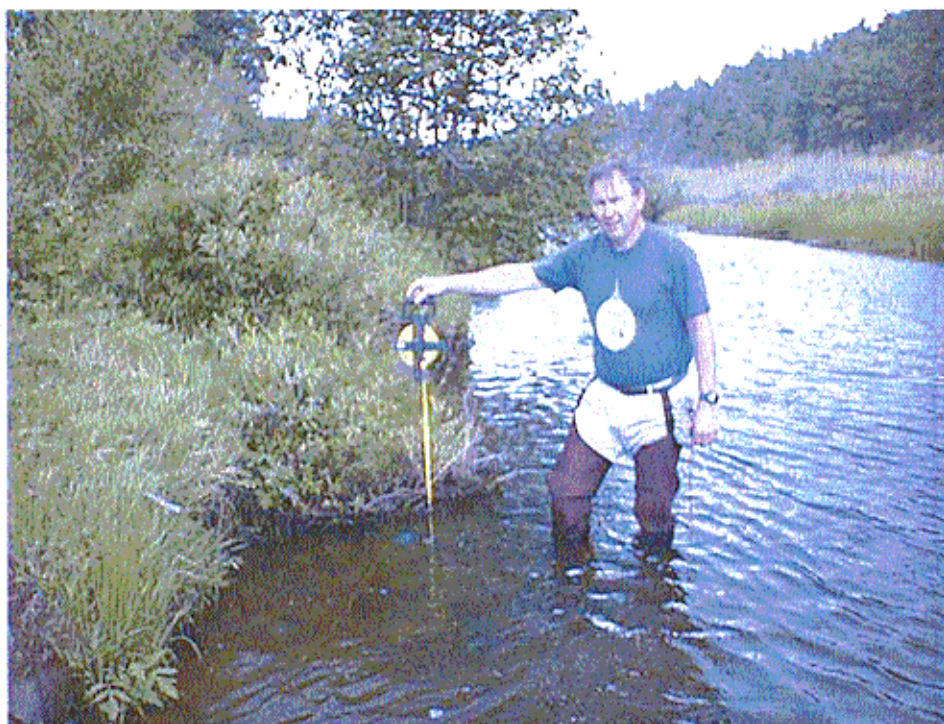
**Photo 12. Rio de las Vacas (NMED Middle Sampling Station 23 – Thermograph T4)**

Station 23, on the Rio de las Vacas, at State Highway 126, shown below, had one TOC exceedance during the summer sampling session and three more during the fall effort. A thermograph was deployed at this station during the same time period as the other two upstream stations. Of the 1,792 readings taken, temperatures varied from 7.0 to 21.0°C, they averaged 13.4°C and only 3 measurements exceeded the numeric temperature criterion of 20°C.
